# Progreso's viaduct in Yucatan, Mexico: First durable concrete structure in the world made with stainless steel

Andrés A. Torres-Acosta<sup>a,\*</sup>, Miguel Martínez-Madrid<sup>b</sup>, Pedro Castro-Borges<sup>c</sup>

## Abstract

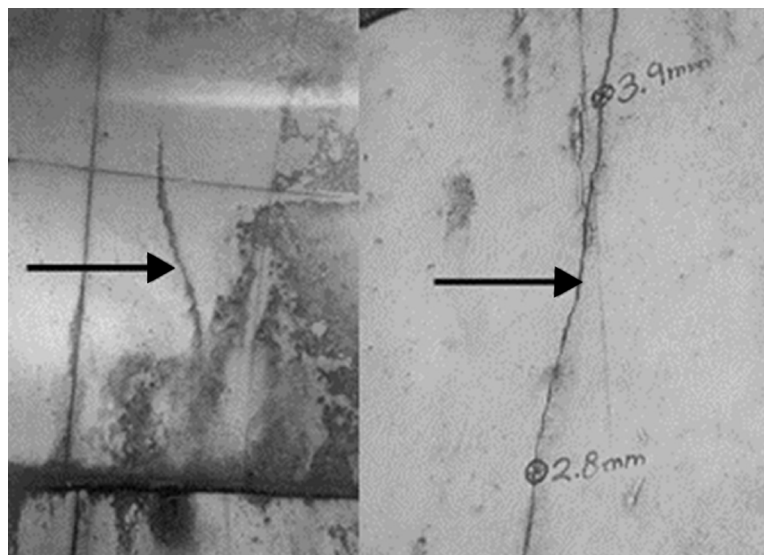
Other results obtained during the continuous evaluation plan, performed by this group, included a detailed crack survey from some of the arches of the viaduct (its pattern is similar to the observed in Fig. 3). This crack intensification has warned API

Figure 3. Typical structural cracks observed on the unreinforced concrete arches.

As an important consequence of the detection of crack intensification (as it has warned API) and beginning of 2003, 54 arches were externally reinforced with Carbon Fiber-Reinforced Polymer (CFRP) composites, which have shown good corrosion resistance and enough structural strength to hold together the cracked arches (see Fig. 4). The way the CFRP bands were

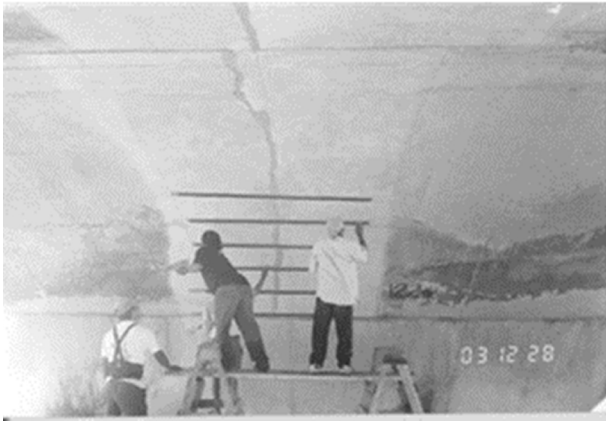
Figure 4. Rehabilitation of one of the cracked arches.

located was conceived to decrease the crack opening due to constant loading of the distress arches.

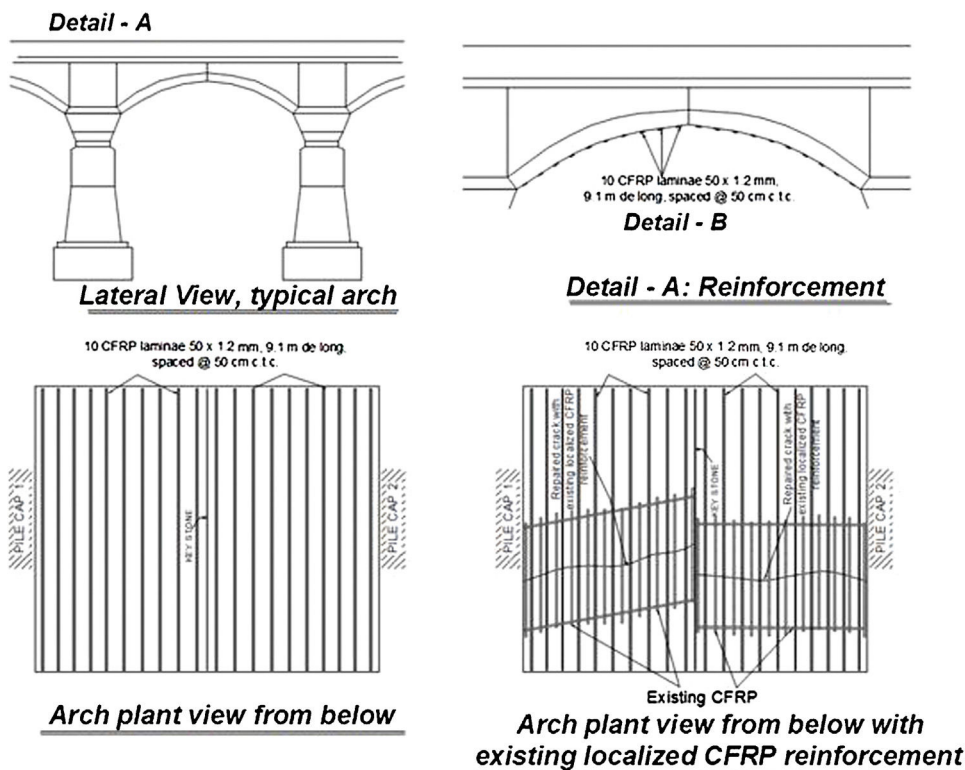
Figure 5. CFRP reinforcement of the cracked arches at the entire arch width. (a) Arch without previous reinforcement, (b) arch previously reinforced with localized CFRP strips.

During a routine inspection in 2007, more arches presents structural cracks, therefore a second rehabilitation work was performed using similar CFRP strips during 2008. However, during this rehabilitation work, additional cracks were observed on the already repaired arches using the localized procedure: CFRP strips glued just in the crack length (Fig. 5). Thus, the procedure of externally reinforced the cracked arches using CFRP strips was changed from localized reinforcement (just placing CFP on top of cracks) to a general reinforcement placing CFP strips on all the width of the arches. In 2009 API obtained additional economical resources to reinforce all the 145 arches of the old viaduct, finishing this work at the end of 2009.
