Special Issue PCF 2014

Welding assessment of a damaged crane pedestal of a container ship

M. Fonte^{a,b*}, M. Freitas^b, B. Li^b, P. Duarte^a, L. Reis^b

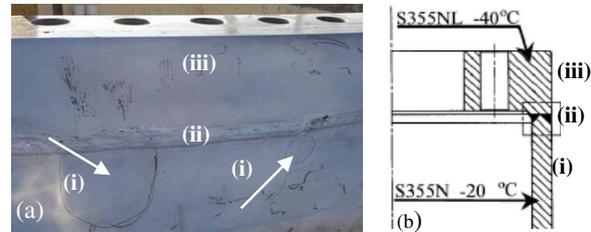
Fig. 2. (a) Crane base pedestal/column surface where cracks were localized (i); (b) column sketch with the upper ring (iii), shell plate (i) and the weld seam (ii).

According to the shipyard report, surface cracks were found at inside and outside of the hot rolled steel plate (25 mm thickness), close to the main weld seam, as is shown in Fig. 2 (a) (i), and some ones also appeared on the welding seam. Most of cracks were found to starboard of the crane. The cracks size ranged between 50 mm and 100 mm long and between 1 mm and 5 mm deep. Cracks were detected by NDT, i.e. magnetic particles and ultra-sounds test. As the cracks size were considered acceptable by the shipyard, the technical services for ship repairs removed them by grinding of the material as it is shown in Fig. 3 (a) and (b) indicated with white arrows.

Regardless some occasional overloads, if the cracks were the result of the normal crane operation, an inadequate maintenance of the pedestal /column surface should not be excluded. The crane and pedestal/column should be painted with shorter intervals. Therefore the pedestal/column should not be replaced by a new one, such as the others were also not replaced.

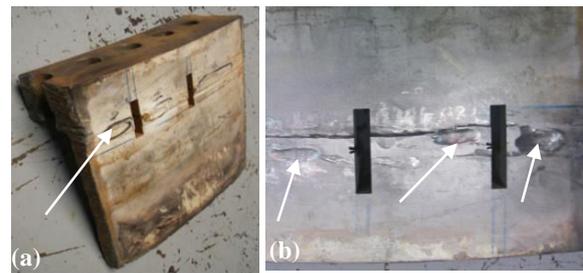
Fig. 3. (a) Flange and (b) hot rolled steel plate, with two holes from where the samples were cut.

Two large samples were cut by oxy-cutting from the rejected pedestal/column at shipyard. From one of them, two small samples were cut by water jet, close to the welding seam cross-section. Fig. 3 (a) and (b) shows the holes from where samples were obtained, as well as the visible zones where cracks were removed by grinding pointed by the white arrows.

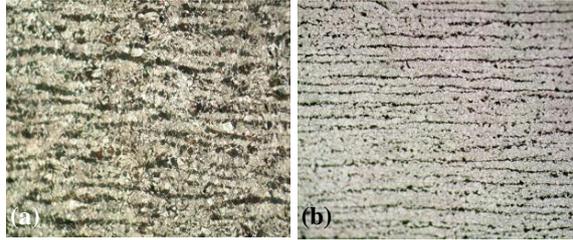
Fig.4. Microstructures of the flange ring (a) and hot rolled steel plate (b), both with 100 X magnification.

Microstructures of the crane upper ring and rolled steel plate were obtained by etching (2% Nital solution) after sample polishing, being observed by optical microscopy. Micrographs are shown in Fig. 4, both with 100 X magnification, being a typical microstructure of these steels, S355NL and S355N.

The image of optical microscopy shows a ferrite-perlite structure with grain bands parallel to the welded seam due to the mechanical treatment. The microstructure does not show any subsequent heat treatment for improving the mechanical properties.

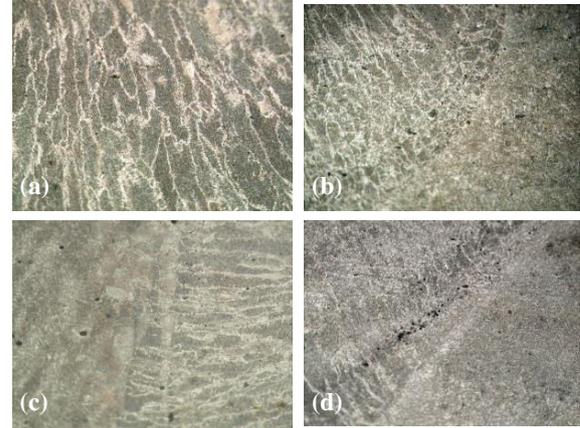
Fig. 5 shows the weld seam cross-section where is possible to observe the micrographs of different weld seams, as well as the fusion limits among them and the heat affected zone (HAZ).

Micrographs show a typical microstructure for this multi-pass welding. Some weld defects such as inclusions and voids were found but are not significant. However the welding defects found at the weld seam are acceptable and cracks were not found.

Fig. 5. (a), (b), (c) and (d) welding microstructure and seam limits, with 100 X magnification.

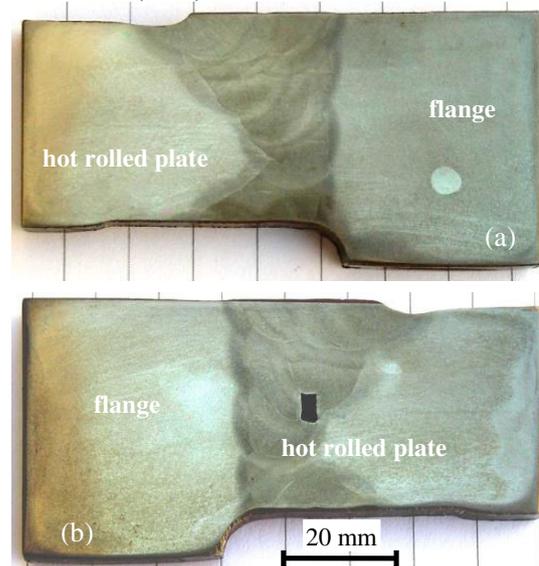
Fig. 6. (a) Weld seam cross-section (double bevel weld seam), where multi-pass weld is observed, and (b) a weld defect (void) at the opposite side of the sample (a).

Some defects such as inclusions and voids were found but they are not of significant importance and may be considered acceptable. Cracks were not found in these macrographs, taking into account the cracks which were eliminated by grinding at the shipyard. It should be also noted that an exhaustive dye check was done at the laboratory before cutting these samples and surface cracks were not found.

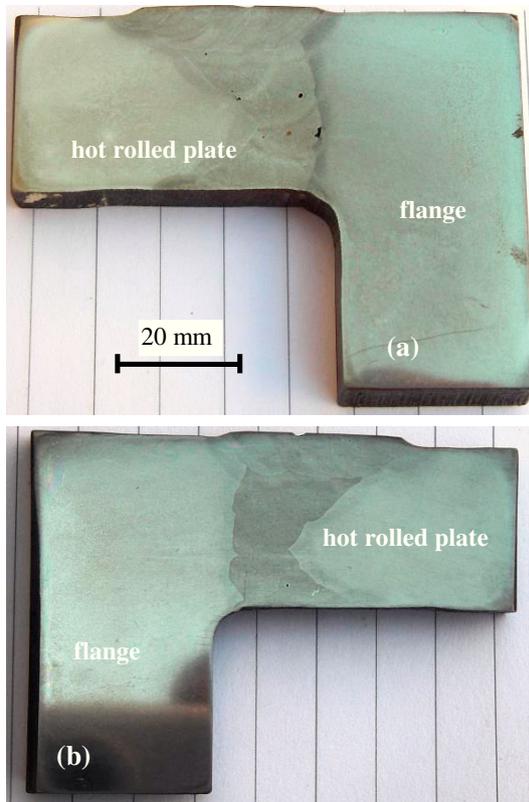
Fig. 7. (a) Weld seam cross-section (double bevel weld seam), where multi-pass weld is observed, and (b) the opposite side of the sample (a).

In Fig. 7 (a) shows the heat affected zones (HAZ), and some defects, like inclusions and voids in the bevel weld seam. However these defect sizes are considered acceptable in welding. Cracks or corrosion effects were not also found.

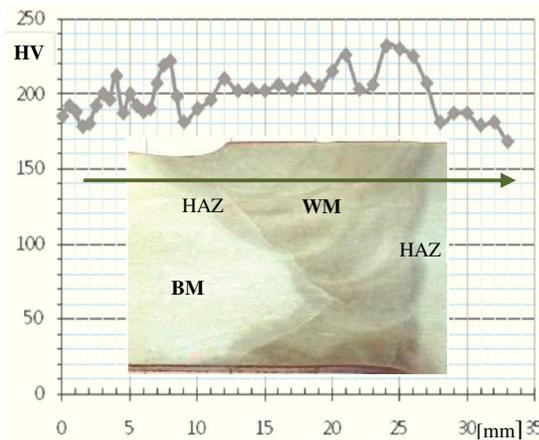
Fig. 8. Cross-section Vickers hardness obtained on the weld metal (WM) according to the arrow direction.

The Vickers hardness measurements were performed to evaluate the mechanical properties of the welding metal (WM). Fig. 8 and Fig. 9 show the Vickers hardness of the weld seam according to the direction lines on the macrographs. The base metal hardness (BM) shows to be lower than in the weld metal (WM). The highest hardness (peaks) occurs at the heat affected zone (HAZ). The Vickers hardness obtained on the cross-direction is uniform without significant peaks among the multiple weld seams.

Vickers hardness values obtained on the weld seam at the cross-direction have no significant peaks among the weld seams and from this one may conclude that the residual stresses are not significant, see Fig. 8, Fig. 9.

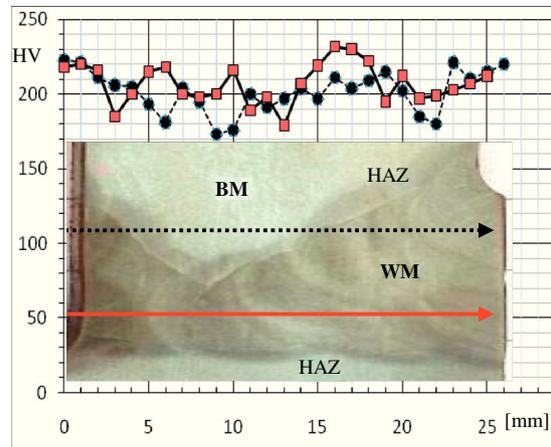
Fig. 9. Longitudinal Vickers hardness obtained on the weld metal (WM) according to the arrows direction.
