# Structures with chloride attack. Application of cathodic protection in the bridge to Illa de Arousa

The bridge of this project is a reinforced concrete structure of 1980 m divided in 40 spans. The deck is a single-cell box girder and a total width of 13 m including sidewalks and shoulders. After 25 years in marine environment, the structure showed reinforcement corrosion, especially in piles and deck bottom.

It was repaired with four types of intervention: conventional reparation with patches, corrosion inhibitors, cathodic protection with sacrificial anodes and an hybrid cathodic protection system with an initial impressed current and galvanic current. In this research it is described the refurbishment and comparative results of the evolution of the repairs and therefore data of the corrosion progression and its effect in service life. The hybrid system, by the moment, is the system with the best results.

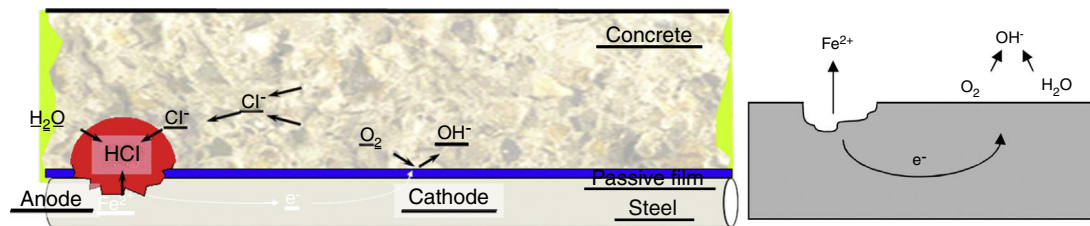
Figure 1. Chloride attack in reinforced concrete and corrosion of iron schemes.

Chloride corrosion, which is generated from a reaction in chain, is usually located in a very limited area of the steel. This is started by the precipitation of particles of hydrochloric acid in that area, the acid dissolves the metal and accelerates the electrochemical reaction (Fig. 1). This phenomenon causes pathology in certain areas of the steel, with a very focused attack in the pit point. This makes it difficult to detect and there is abundant casuistry of failure of structures due to this type of corrosion.

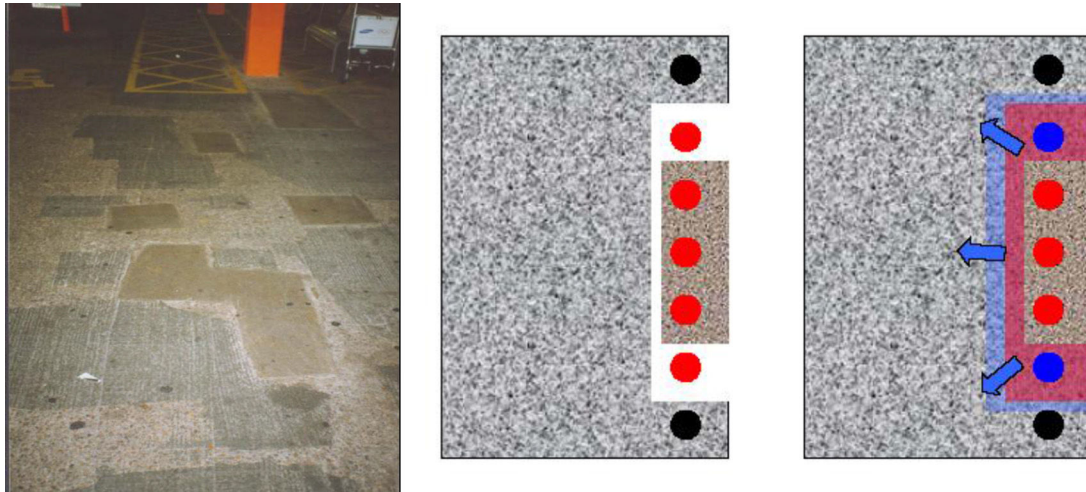
Figure 2. Examples of patch repair and repair with mortar with corrosion inhibitors.

- Conventional reparation in patches. This is the most traditional repair system. It consists of the clean up of the affected areas, uncovering the rebar and applying new mortar to restore the affected area to its original state. This is the fastest and most economical repair option. In case of severe corrosion, this type of repair can produce new corrosion in the perimeter of the repaired area (Fig. 2). Also, there is a “radial expansion” over time. This phenomenon is known as incipient anode.

- Repair with mortar with corrosion inhibitors. A breakthrough to conventional patch repair is the use of hydraulic mortars modified including migratory corrosion inhibitors. These are polymeric products, which create a protective film around the steel; with this, there is a reduction of the possibility of corrosion by chemical attack. The fact that they are migratory products makes these able to penetrate into the concrete mass located on the perimeter of the patch. The distance that these products can penetrate in the concrete mass is based on Fick’s law.

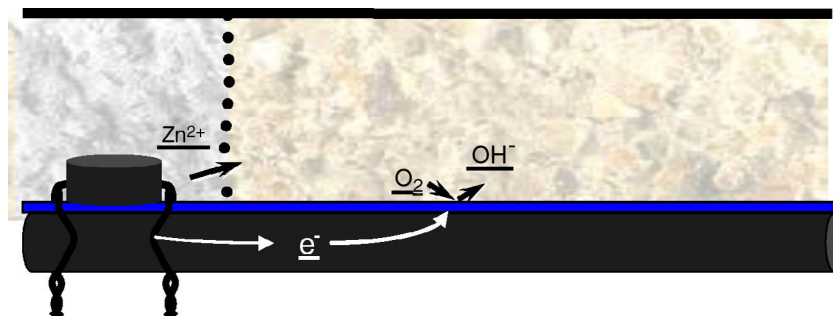
Figure 3. Example of sacrificial anodes protection.

- Cathodic protection with anodes of sacrifice. This method uses the knowledge of the scheme corrosion of steel in reinforced concrete, and in particular, the scheme of chloride attack. It applies sacrificial anodes in the perimeter of the repair; with this it prevents the creation of incipient anodes in the outside of the repair patch. Also, it is in compliance with the electrochemical scheme already established in the steel rebars. As stated previously, the corrosion of the sacrifice metal itself is at the same time, protecting the adjacent steel (Fig. 3). This is because the corrosion acidification leads

to the re-alkalinization of the contiguous steel, protecting it thanks to the hydroxyl groups that migrate to these areas. This is the principle of cathodic protection, allow controlled corrosion (in this case the anode, not the steel bars), and the re-alkalinization and protection of steel in the vicinity of the anode.

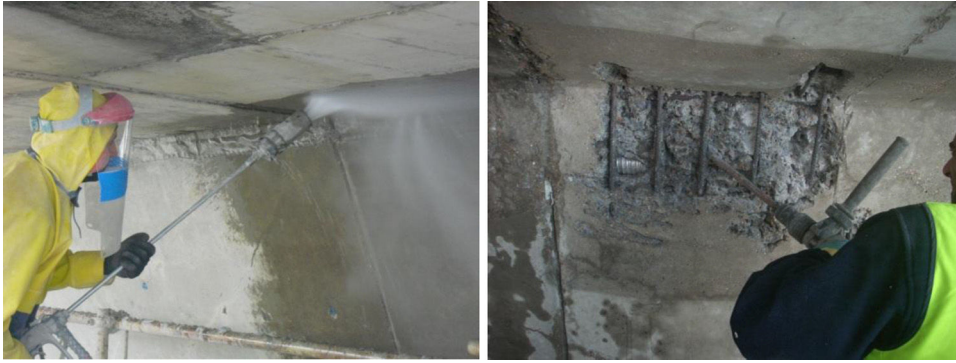
The sanitizing carried out in the damaged areas was performed with two methods, one manually by chipping hammer and the other by hydro-demolition machine, which proved to be

the most effective method, both produced acceptable quality and cleanliness of the demolish (Fig. 4).

Figure 4. Techniques of demolition of damaged areas of the deck.

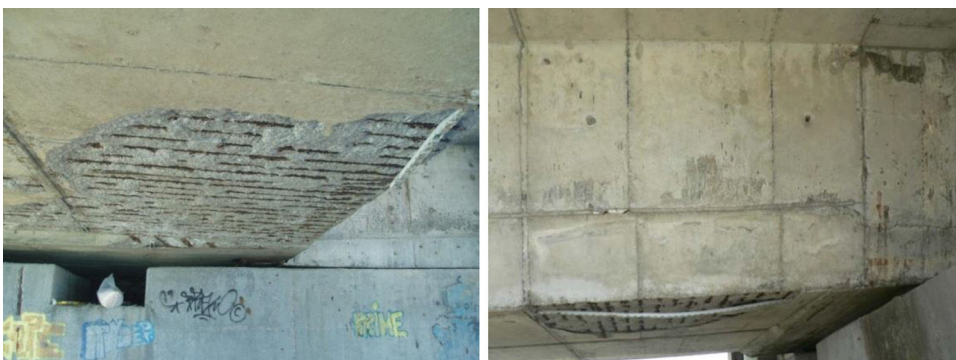
It was detected that many existing corrosion problems had been caused by defects in the concrete placement. In addition, in the project of the bridge it was established to use continuous plastic along the rebars. This type of spacer for reinforcing bars

was a novelty at the time and it favoured substantially the entry of aggressive agents more directly and quickly (Fig. 5).

Figure 5. Affected areas of the bottom of the concrete girder.

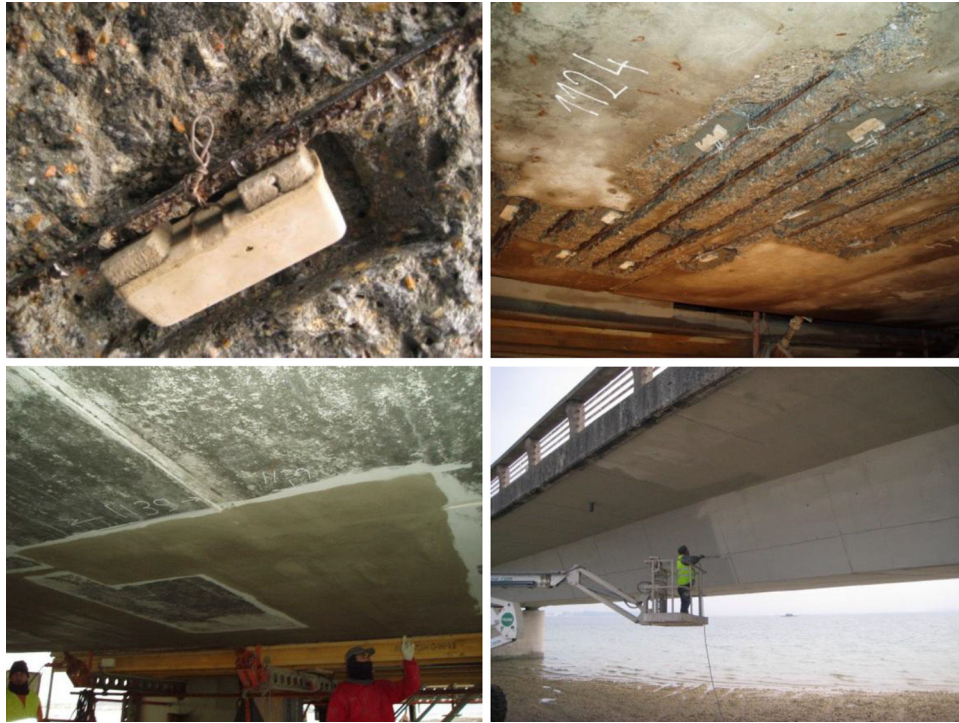
Figure 6. Details of the repairing procedure (sacrifice anodes, application of mortar patches and final painting).

The repair was carried out on the deck consisted of sanitizing each damaged area, replacement of steel in areas where the loss of section was excessive (Fig. 6). After this, placing discrete zinc anodes in the area of repair, next the application of thixotropic mortars. And finally, the entire surface of the deck (repaired and unrepaired areas) was painted with a special anti-chloride paint.

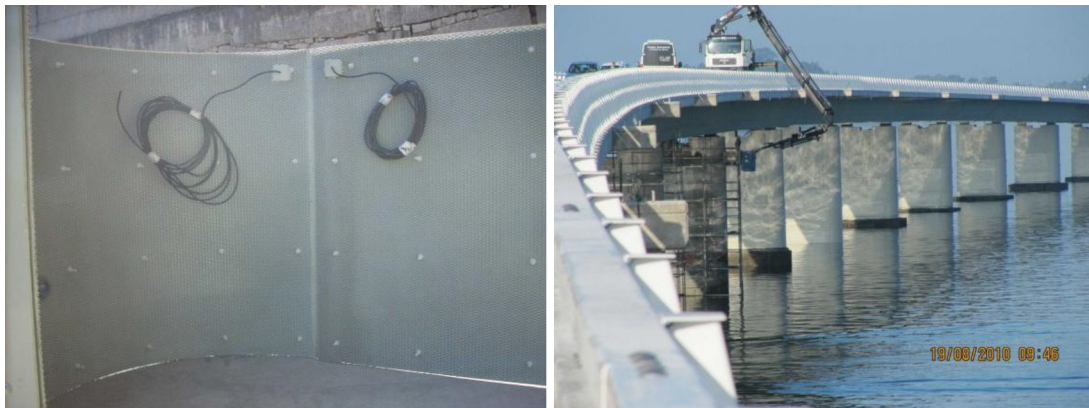
Figure 7. Repair of the piles with the Fosroc jackets.

- Conservation of one of the piles with conventional repair and without cathodic protection. This will serve as reference and permit comparison for the deterioration of the bridge without cathodic protection.
- Conventional repair + cathodic protection jacket system (Fosroc). This system consists of placing some jackets of fibreglass mesh + zinc batteries. Filling the gap between the pile and the jacket with a special concrete that allows the current flowing between the mesh of zinc and the reinforcement (Fig. 7). This

system was used in a limited group of piles because of the difficulties of the works in the areas hit by the sea. All circuits for the reinforcement and the zinc anodes was conducted to the deck and connected in electric boxes protected inside de girder box. This makes monitoring over time easy.

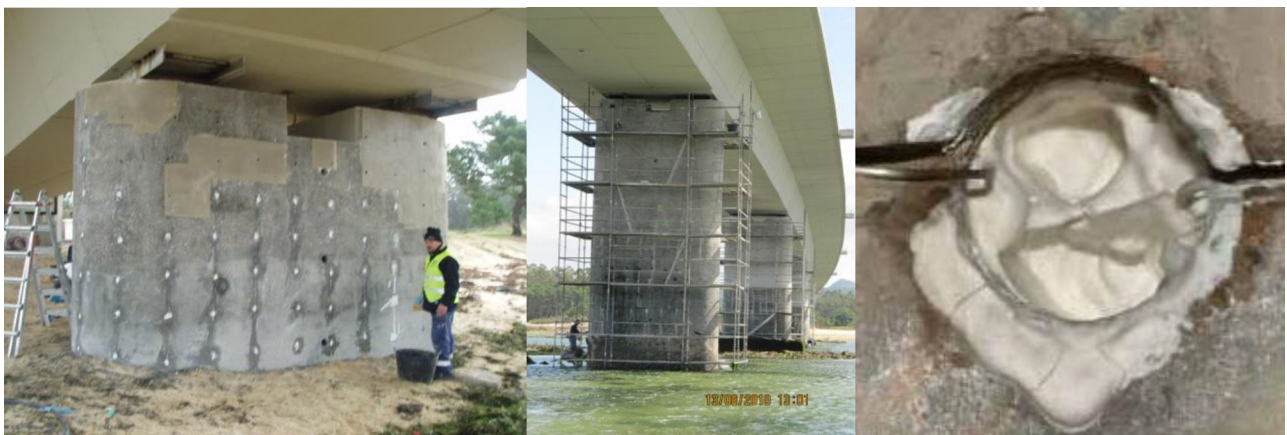
Figure 8. Repair of the piles with conventional technique and CPT cathodic protection.

- Conventional reparation + cathodic protection system with the hybrid system (CPT). The functioning of this technique stems from the introduction of sacrificial anodes in small holes in the structure and all embedded in a mortar of activation. The arrangement of sacrificial anodes was made based on a grid designed according to the detected damage and location relative to the different zones: tidal, splash, etc. These anodes are connected through titanium wire that closes the circuit against reinforcement steel bars, which in turn are connected in a connection box within the board for later supervision (Fig. 8).

The network of anodes and wiring permits the application of impressed current for a short period of time. This was performed initially after the repair works, however it can also be applied after a period of time since the intervention with a similar effect. What is seek is to produce the re-alkalization of the structure, with the consequent prevention of chloride attack. This delayed treatment would be possible simply using external batteries and for a very short period of application, between 1 and 2 weeks. Thereafter the system is disconnected from the battery, starting its operation as conventional sacrificial anodes. The new electrochemical equilibrium starts from steel in a substantially

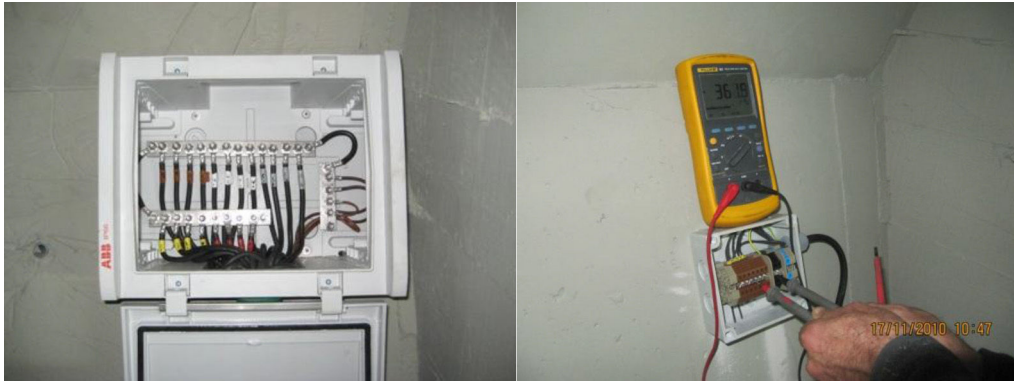
Figure 9. Detail of a connection box and the procedure of measurement of the voltage.

As mentioned above, the repair performed included innovative solutions in many aspects, which include monitoring by monitor the cathodic protection. It is possible to measure the connections between the sacrifice anodes and the steel reinforcement, they are accessible in boxes for collecting data that allows the tracking of the installed systems (Fig. 9).

The monitor is designed to take data selectively from different areas of the bridge (north side, south side, splash zone, tidal zone). In this way, it is planned a detailed monitoring of the installed systems. It would permit to compare different electric consumption in the cathodic protection of the different zones depending on the aggressiveness of the areas.

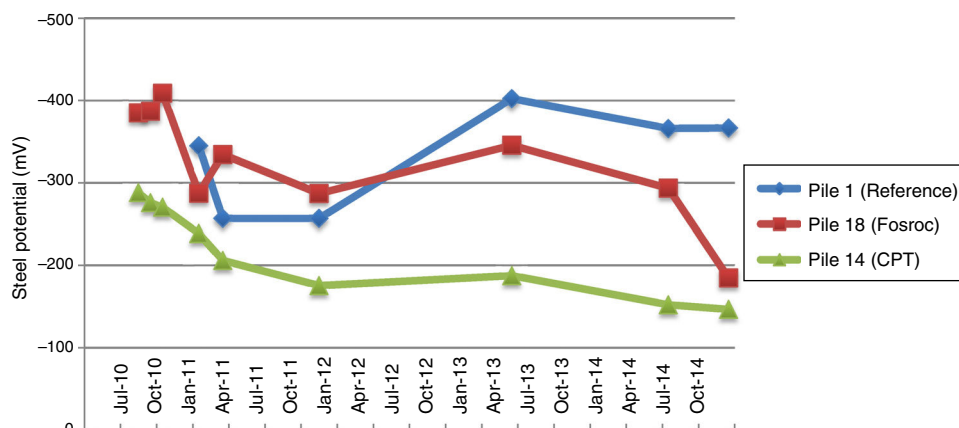
The follow-up visits have produced extensive measurement campaign data. This enables to assess the correct behaviour of the cathodic protection. Ensuring that they fulfil the criteria established by UNE 12696: 2000 and EN 12696 [7]: 2012. Also, it has been made, in first instance, corrosion potential measurements according to ASTM C876-09 [8]. In Fig. 10 are

represented results of pile potential in different areas of the bridge repair.

In the displayed graphic is observable the different behaviours on different cathodic protection systems employed in the repair of the bridge. As we can see in the case of pile 1, where it was performed a conventional repair, the corrosion potentials were after two years of the repair, below  $-350$  mV. With the predefined criterion of corrosion (less than  $-200$  mV), we would be in a case of highly probable corrosion [6].

In the case of the pile 14, in which it was used the system of discrete anodes with CPT hybrid cathodic protection, we see as a major change in the corrosion potentials, led by the first contribution impressed current applied at the initial time [9]. We see potential are above  $-200$  mV almost from the start, and the trend is almost horizontal with over the years.

The next case is the one of pile 18. In this pile it was used for galvanic protection the system of Fosroc GRP shirts that were covered with zinc anodes. In this case, the corrosion potentials have a different behaviour than the CPT system. As it can be seen, in this case the corrosion potentials increase rapidly after the repair work. With time, the protection system becomes more positive, slowly coming closer to the values given by the CPT system values. The fundamental difference is that this system does not give an initial contribution of impressed current, so that the potential of corrosion of steel are essentially the same as existed prior to the repair. Over time, the potential becomes

Figure 10. Results of the evolution of the pile potential (V) in the period 2010–2014.

increasingly positive; turning to over  $-200$  mV positive values, which indicates almost certainly the passivity of steel in reinforced concrete.
