BRIEF REPORTS

Pseudo dislodgement of a stent due to crumpling of a coronary artery: A hitherto unreported complication of the “accordion effect”

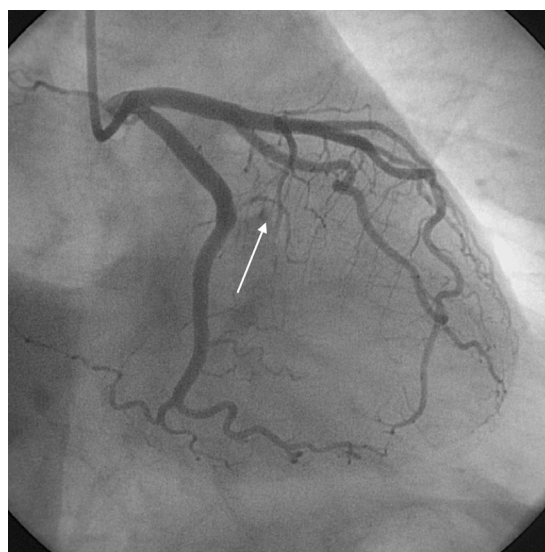
Figure 1 Coronary angiography in RAO projection illustrating only partial and filiform filling of 1st MB. Note the absence of disease in the remaining vessels. RAO = right anterior oblique; MB = marginal branch.

A 52-year-old woman, without history of heart disease or risk factors was admitted in the Coronary Care Unit (CCU) with an acute myocardial infarction and immediately transferred to the Cath Lab for primary angioplasty. Coronary angiography revealed a complete occlusion of the first marginal branch without evidence of atheromatosis in the remaining vessels (Fig. 1). After beginning anticoagulation with unfractionated IV heparin a 6 Fr EBU 3.5 (Medtronic, Inc.) guiding catheter was positioned in the left ostium. A 0.014 in. Choice® Floppy guidewire (Boston Scientific) was advanced with some difficulty through the occluded vessel and a 2.5 mm × 20 mm Maverick® balloon (Boston Scientific) was inflated with only partial restoration of the lumen and incomplete distal filling. An Atlantis® SR Pro (Boston Scientific) intravascular ultrasound catheter (IVUS) was advanced and a long dissection extending from the ostium to the distal part of the artery was observed (Fig. 2). In that moment two PROMUS® (Everolimus-Eluting Coronary Stent, Boston Scientific) stents, 2.25 mm × 24 mm and the second one of 2.25 mm × 16 mm were deployed with 1 mm overlapping between them, thus completely covering the long dissection and restoring normal flow (Fig. 3A–F).

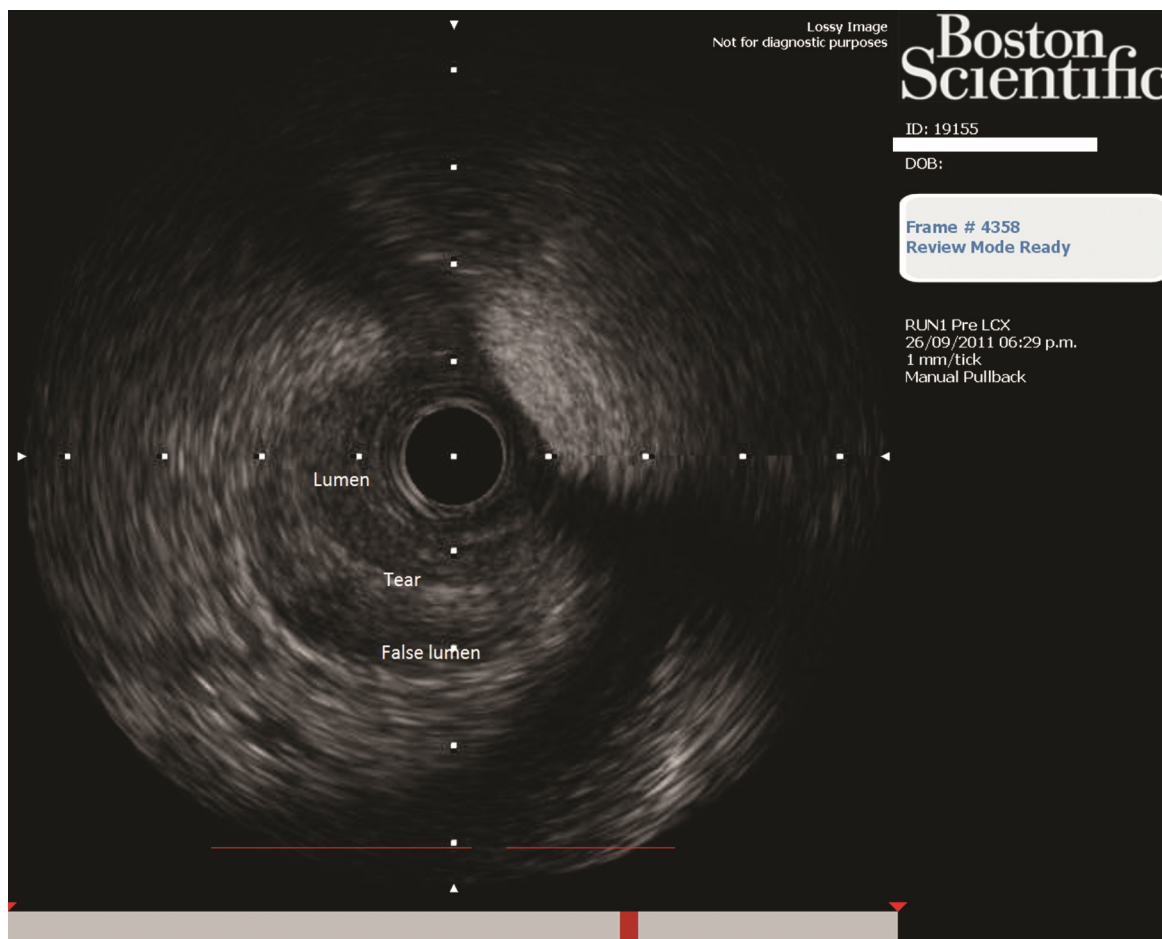
Figure 2 IVUS 2D tomographic image of the occluded MB: the semicircular dissection membrane is seen as a very thin echo-dense line separating the false lumen from true lumen. IVUS = intravascular ultrasound.

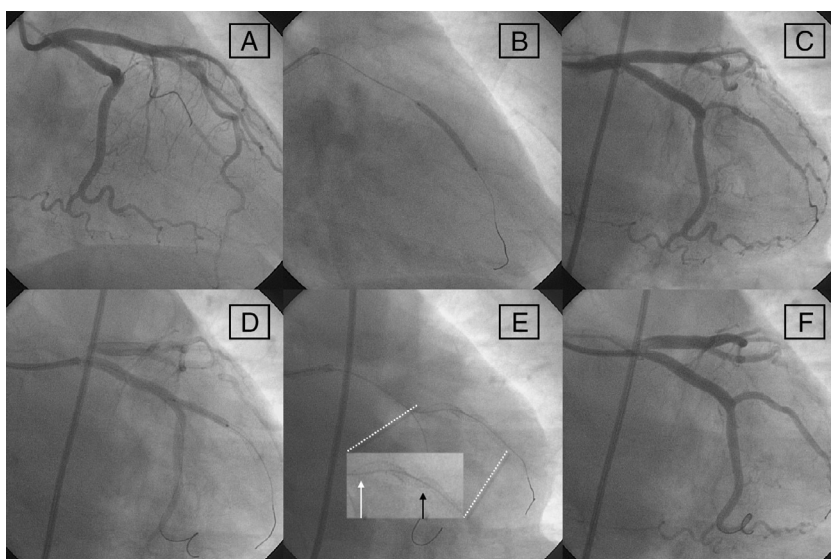
Figure 3 Angioplasty sequence in RAO. (A) Filiform filling of 1st MB; (B) distal stent deployment; (C) angio post distal stent; (D) proximal stent deployment; (E) stents correctly positioned from the ostium of the 1st MB (*white arrow in zoom*) with 1 mm overlapping (*black arrow in zoom*) between them; and (F) final result without retrieving the wire.

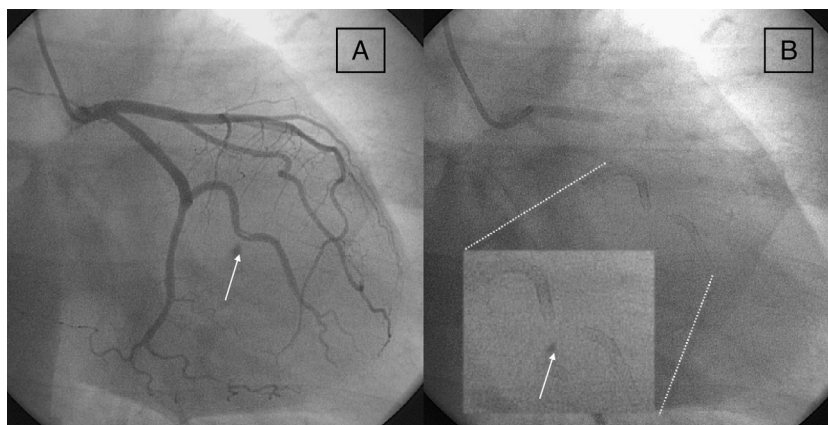
After retrieving the wire a new angio showed two gaps, one between the ostium and the proximal side of the proximal stent, and another between the two deployed stents, with a nonocclusive dissection between the stents (Fig. 4A and B). We tried to reposition the 0.014 in. wire in the artery but the attempt was unsuccessful because of the tortuosity of the vessel and the struts of the stents, so we decided conservative management.

Figure 4 Post stenting angiography in RAO projection after removing the guidewire. (A) Note the dissection in the mid portion of the artery (*white arrow*). (B) Note the gap between the previously overlapped stents (*white arrow in zoom*). RAO=right anterior oblique.

In this scenario, stenting of the real lesion may be challenging. In this case of a young woman with an acute myocardial infarction, the first marginal branch was totally occluded; distal positioning of a floppy wire was difficult but possible and after inflating the balloon the lumen was only partially restored. The suspicion of a long dissection as the main mechanism of the occlusion was confirmed with IVUS. Deployment of the two stents was easy and special care was taken in the ostial position of the proximal stent and in overlapping with the distal stent in order to cover the whole dissection. After retrieving the wire the artery assumed a tortuous shape and two uncovered gaps appeared, one between the ostium of the marginal branch and the proximal margin of the stented segment, and the other between the two stents (previously overlapped stents). Neither the proximal nor the distal stents moved from its original place. Our diagnosis is that the artery was crumpled and after retrieving the wire assumed its original length, thus leaving two small dissected segments without stent covering. The diagnosis of “accordion effect” could not be previously done in a totally occluded artery with a long dissection.
