## Cement arteriovenogram after hip arthroplasty<sup>☆</sup>

**Abstract** Modern cement implantation techniques during hip arthroplasty rely on high intramedullary pressures which can result in cement extrusion towards femoral nutrient vessels, and thus, the occurrence of a particular image in postoperative radiographs (bone cement arterio-venogram).

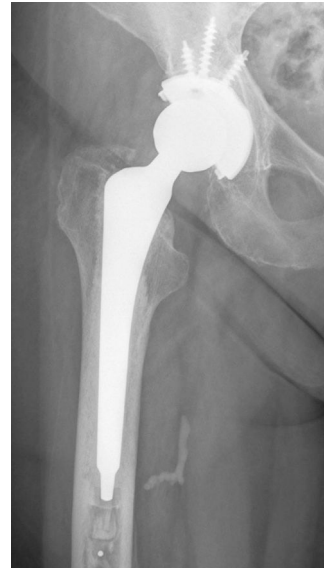
**Figure 1** Example of cement arteriovenogram in a total hip arthroplasty. The characteristic radiographic image is shown, of linear and ascending morphology, positioned in the postero-internal side of the proximal femoral third.

We present a series of cases recorded in our centre of migration of cement through a tributary vein or artery of the femoral diaphysis while performing partial and total cemented hip prostheses (Fig. 1).

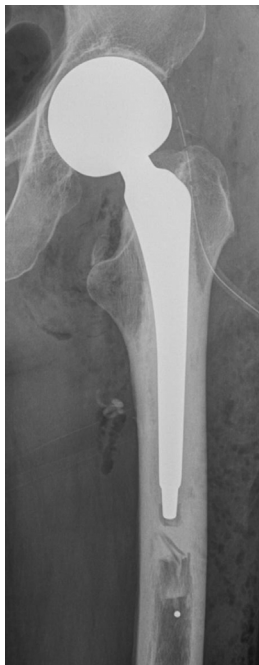
**Figure 2** Cement arteriovenogram in total hip prosthesis. Postero-internal radio-opaque image that suggests the route of a femoral nutrient vein, showing its valves.

The constancy of the postero-internal location and at a distance that could correspond to the anatomical position of this femoral nutrient bundle should lead us to consider extrusion of the cement towards the veins or arteries that make up the bundle (Fig. 2). Likewise, the linear morphology of the radiographic image suggesting the vessel being occupied by cement, venous valves being observed, differs completely from that produced by a cortical defect or a periprosthetic fracture (Fig. 3), which would result in an irregular image without tubular appearance or the presence of valves.<sup>13</sup>

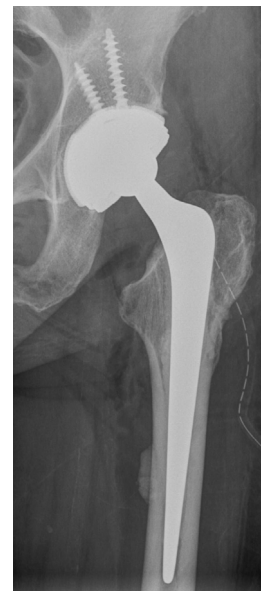
**Figure 3** Probable cortical defect. An irregular radio-opaque image is observed that apparently does not show any vessel, and therefore a cortical defect should be suspected, and a scan requested to rule out periprosthetic fractures.
