Special Issue “Materiais 2015”

Resistance of a nonwoven geotextile against mechanical damage and abrasion

Mónica Dias^a, José Ricardo Carneiro^{b, *}, Maria de Lurdes Lopes^b

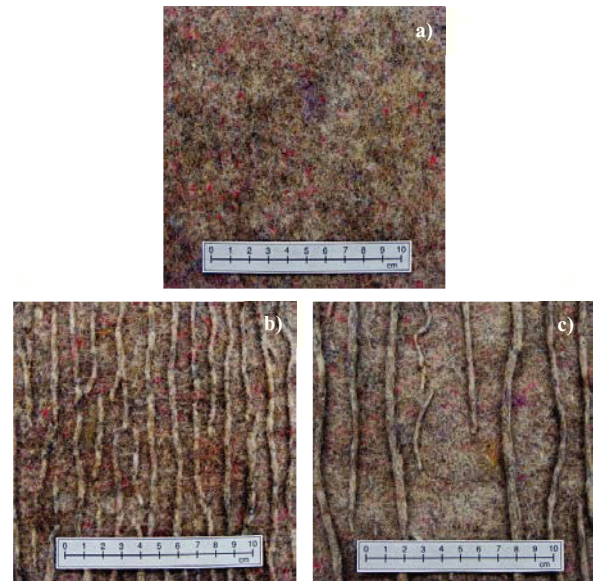
Fig. 1 compares the damage found in the geotextile after the different degradation tests.

Fig. 1. Nonwoven geotextile: a) after mechanical damage (global appearance similar to undamaged – the defects cannot be seen at this magnification), b) after abrasion and c) after mechanical damage followed by abrasion.

The degradation tests led to different types of damage in the geotextile. The mechanical damage tests caused cuts in fibres, small holes and imprisonment of fine particles (arising from the fragmentation of corundum) in the nonwoven structure of the geotextile.

The type of damage caused by the successive exposure to mechanical damage and abrasion was similar to abrasion (single exposure), but more marked (more fibres were cut and the clusters tended to be bigger).

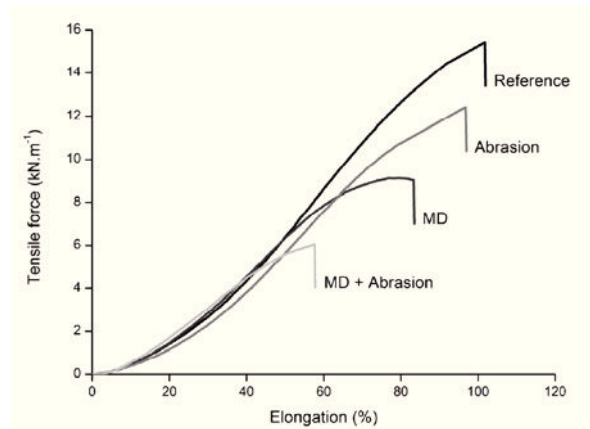
Fig. 2. Mean curves “tensile force-elongation” obtained before and after the degradation tests.

The mechanical damage test caused a decrease in the TS and E_{ML} of the geotextile (reductions of 38.2% and 25.8%, respectively). The changes in tensile properties induced by abrasion (reduction of 20.2% in TS and no relevant changes in E_{ML}) were less marked than those provoked by the mechanical damage test. The highest reductions in tensile properties were observed after the successive exposure to both degradation tests (60.1% decrease in TS and 44.3% decrease in E_{ML}) (Table 1). The mean curves “tensile force-elongation” (obtained before and after the degradation tests) are illustrated in Fig. 2. In addition to changes in TS and E_{ML} , these

curves also show that the degradation tests provoked a reduction in stiffness at higher elongations.

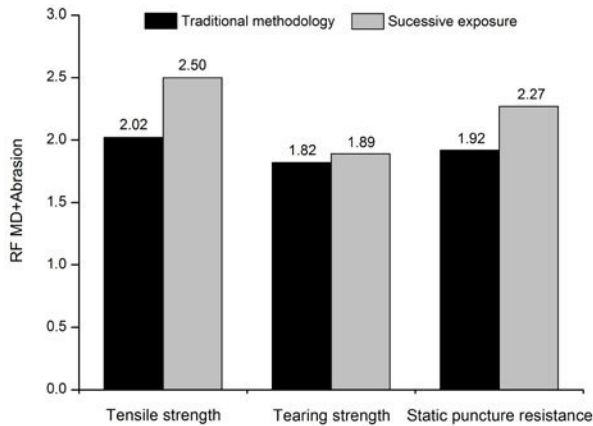
Fig. 3. Comparison of the reduction factors (RF_{MD+ABR}) obtained by the traditional methodology and by the successive exposure to both degradation agents.

By the traditional methodology (considers the isolated effect of the degradation agents), the reduction factor for the combined effect of mechanical damage and abrasion can be obtained by multiplying the reduction factors determined individually for each agent ($RF_{MD} \times RF_{ABR}$). Fig. 3 illustrates a comparison between the reduction factors thereby obtained and those found in the successive exposure to both agents.

The reduction factors found in the successive exposure to mechanical damage and abrasion were higher than those obtained by the traditional methodology for the combined effect of both agents. The highest difference was found for TS (reduction factors of 2.50 and 2.02, respectively). By contrast, for F_T , the difference was quite small (1.89 and 1.82, respectively).

The previous results indicate that the reduction factors determined by the traditional methodology may not be representing correctly (underestimating) the combined action of mechanical damage and abrasion. Indeed, the traditional methodology was less conservative, tending to give smaller reduction factors.
