Clinical report

Management of an infected temporomandibular joint prosthesis and the use of bone cement with antibiotics

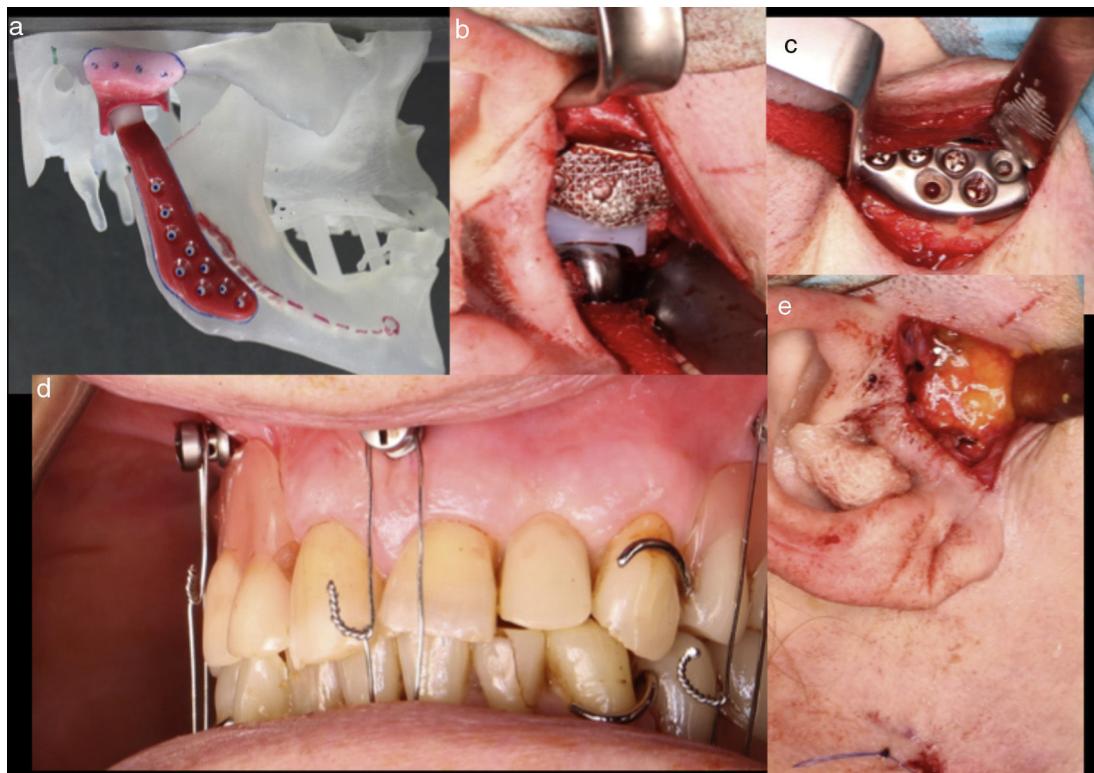
Fig. 1 – (a) Custom made TMJ prosthesis with 3-D stereolithographic model, (b) and (c) fossa and mandibular component of the prosthesis, (d) final occlusion, and (e) fat graft to fill death space.

We performed a total joint replacement according to the protocol established in our department (Fig. 1). The patient had i.v. antibiotic prophylaxis with clindamycin plus gentamicin and went under post-operative antibiotic regimen with clindamycin 300 mg orally every 8 h as usual when she was discharged.

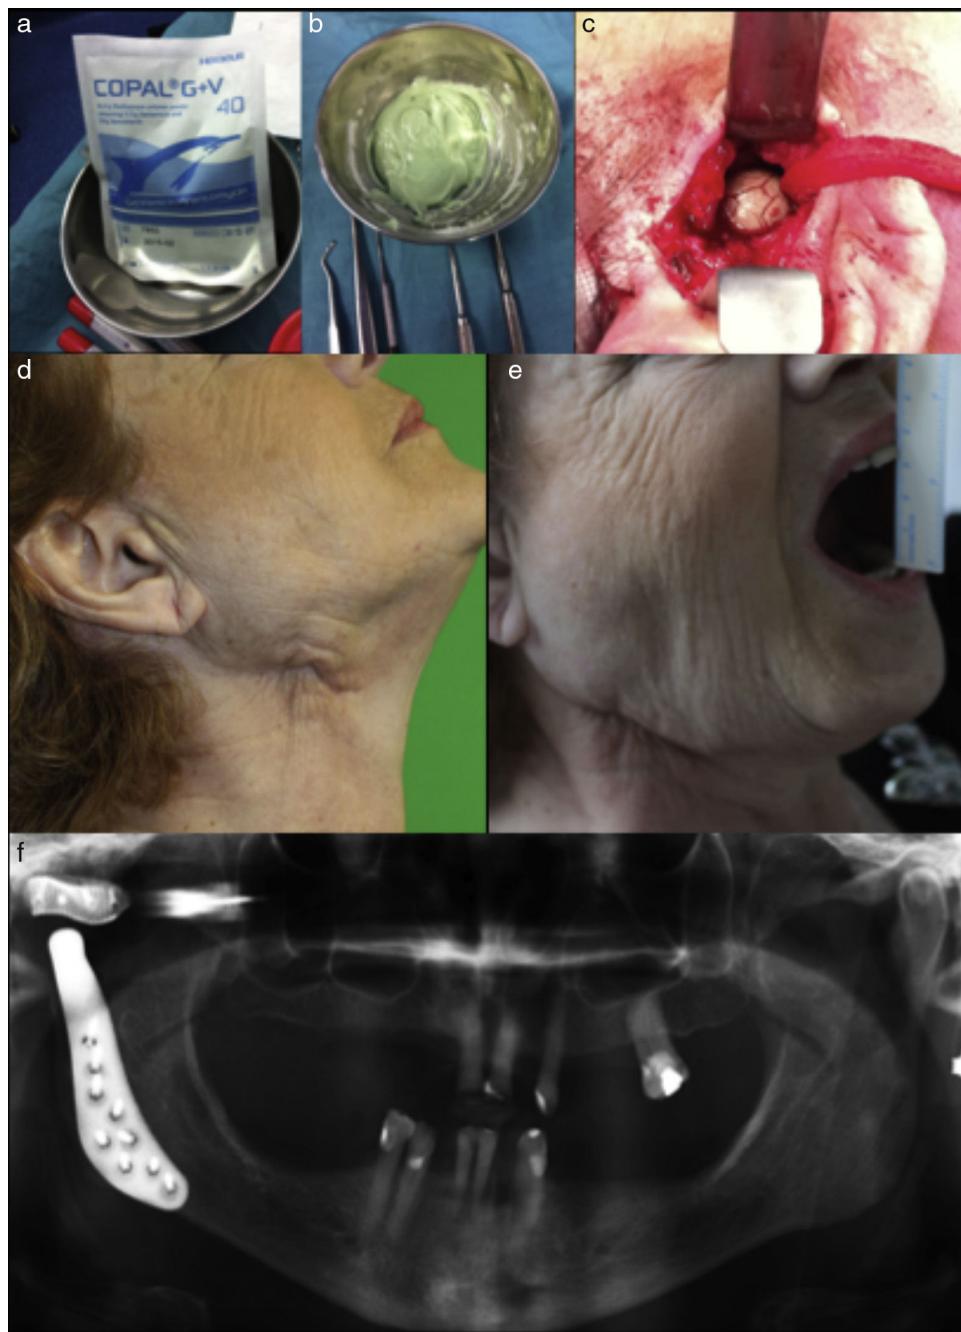
Fig. 2 – (a) and (b) Polymethyl methacrylate orthopedic cement impregnated with antibiotic, **(c)** bone cement placed to maintain fossa space, **(d and e)** eleven months after new TMJ replacement free of symptoms with good mouth opening, and **(f)** radiographic control after replace a new custom made fossa and reimplant the condylar component.

The culture of the material obtained intraoperatively showed growth of *Proteus mirabilis*, so we added piperacillin-tazobactam as a new antibiotic. However, even with the new antibiotic the infection continued. The patient underwent surgery to remove the infected prosthesis and debridement. Polymethyl methacrylate orthopedic cement, impregnated with 0.5 g gentamicin and 2 g of vancomycin (Fig. 2a and b), was placed to maintain the fossa space, eliminating the need of intermaxillary fixation (Fig. 2c).

She was treated for 10 more days with IV antibiotic treatment consisting of Vancomycin and piperacillin-tazobactam, and linezolid 600 mg every 12 h and ciprofloxacin 750 mg every 12 h for four more weeks. She returned to the operating room six months after finishing the antibiotic treatment to replace a new custom made fossa and reimplant the condylar component after sterilization by the manufacturing company. The patient is now symptom free eleven months after surgery (Fig. 2d-f).

Polymethyl methacrylate orthopedic cement, impregnated with antibiotic is useful, to maintain fossa space, and to decrease the biofilm formation⁴ between the time of the infected TMJ prosthesis removal and the second stage replacement.
